Cambers of prestressed precast bridge girders, prediction vs. reality

ABSTRACT: This paper deals with investigation of reasons of deviations of actual cambers from predicted values that were observed on precast bridge girders where prestress transfer is divided into two stages. The first part of prestressing is introduced by pre-tensioned strands and usually starts only 18 hours after casting and the second part by three post-tensioned curved tendons stressed one or two month later. The problem was analyzed from structural and technological aspects.

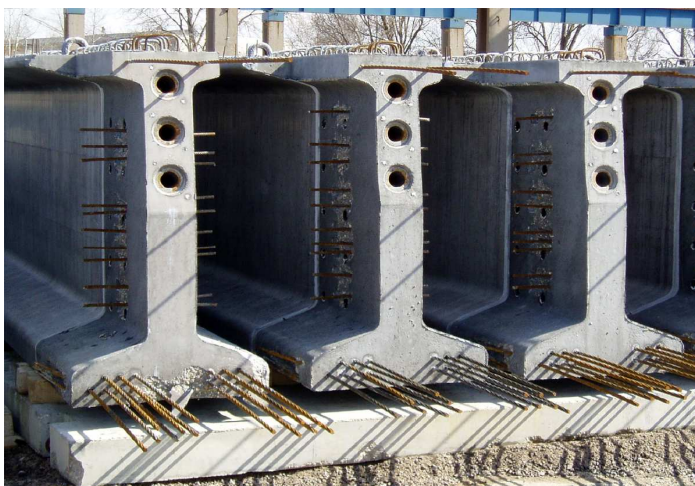
Continuous slab-on-girder bridges with RC diaphragms belong to the most frequent option for construction of long elevated highways in Slovakia. These bridges are mostly composed of 32 m long precast beams with the depth of 1,4 m, see figure 1. Construction technology required dividing of prestressing into two parts. The first part is introduced by pre-tensioned strands 18 hours after beam casting and the second part through three post-tensioned curved tendons stressed one or two month later. Each tendon consists of four strands (strand sectional area is $141,6 \text{ mm}^2$ and $f_{pk} = 1800 \text{ MPa}$). During construction of the elevated 17 span highway in northern Slovakia, some important differences were found

Figure 1. Beams at storage yard

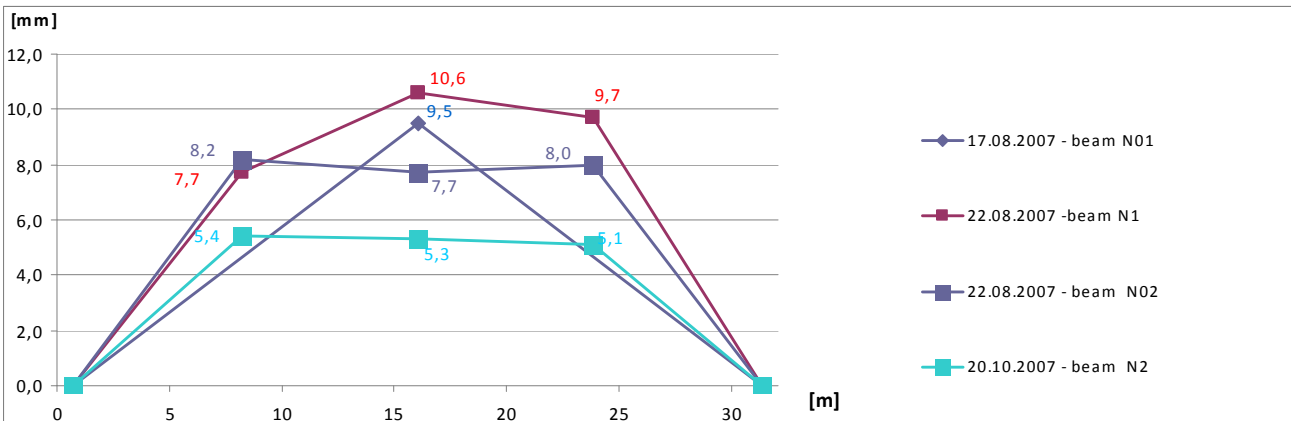
Measured deformations just after prestress transfer of pre-tensioned tendons are in figure 2. Applied prestressing forces that had always lifted beams and

Figure 2 Cambers of the beams just after prestress transfer in formwork

measured cambers were even higher than the predicted value 7,5 mm for the most of the monitored

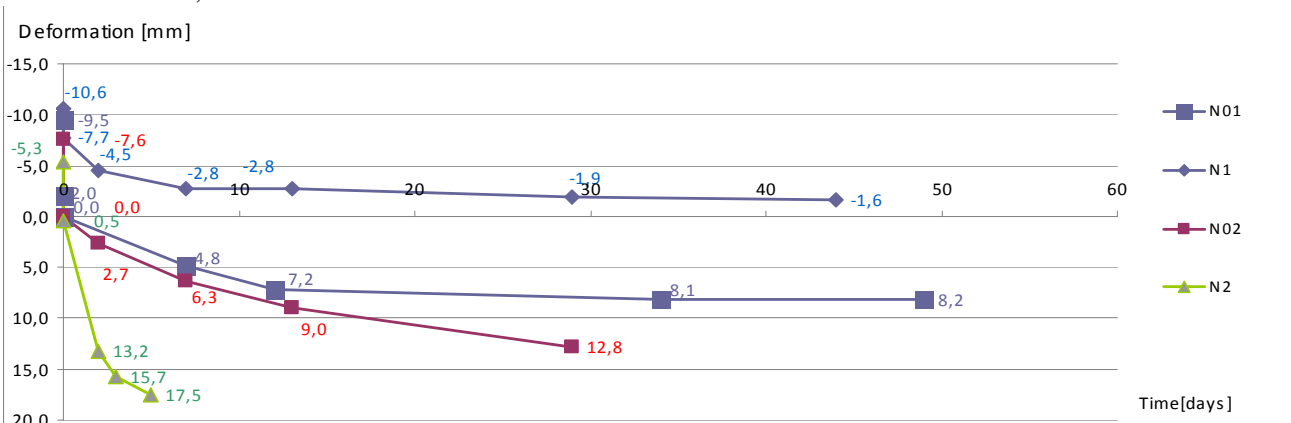
Figure 3 Development of cambers in the middle of the beams

beams. However beams began to loose their camber within several minutes, see figure 3, 4 and original cambers changed into deflection in many cases contrary to the prediction when increment of cambers was expected. The same behavior was observed on the beams N3 and N4 with separated upper strands. A large range of deformation was very typical.

Time development of the concrete strains is in figure 9. Increment of strains (shortening) measured by upper strain gauges has always been larger than in lower ones. It confirmed development of deflection in the middle of the beams, see also figure 3, particularly for beam N2. These deflections were not result of long-term prestress losses, because e.g. the prestress losses in beam N2 were only -17 MPa within 5 days.

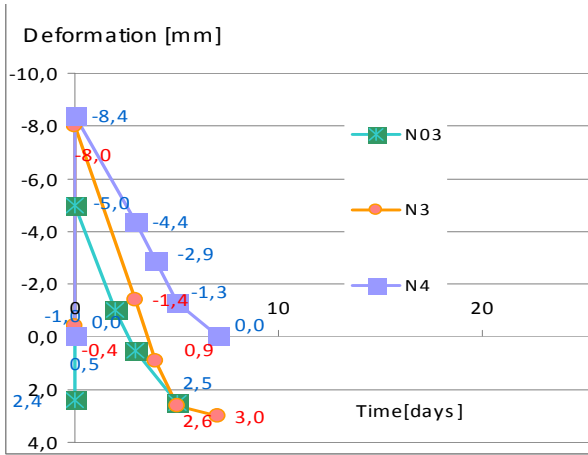
Figure 4 Development of cambers

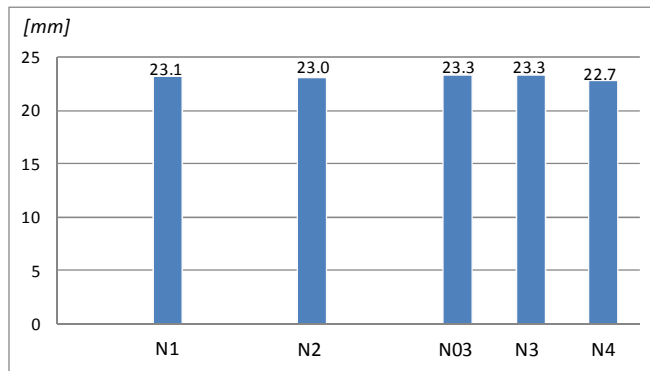
Much better results were obtained during stressing of post-tensioned tendons. Measured deformation due to effect of three four-strand tendons is in figure 5. Increment of cambers was ranging between 22,7 mm and 23,2 mm. These results were also in very good coincidence with predicted values 22,8 mm. Assessment of beam deformation was carried out assuming mature high-performance concrete C55/67 and an average modulus of elasticity of 45 GPa. These values are proven by laboratory tests of more than 300 cube samples tested on strength and 50 prisms tested on modulus of elasticity.

Figure 5 Deformations due to post-tensioned tendons

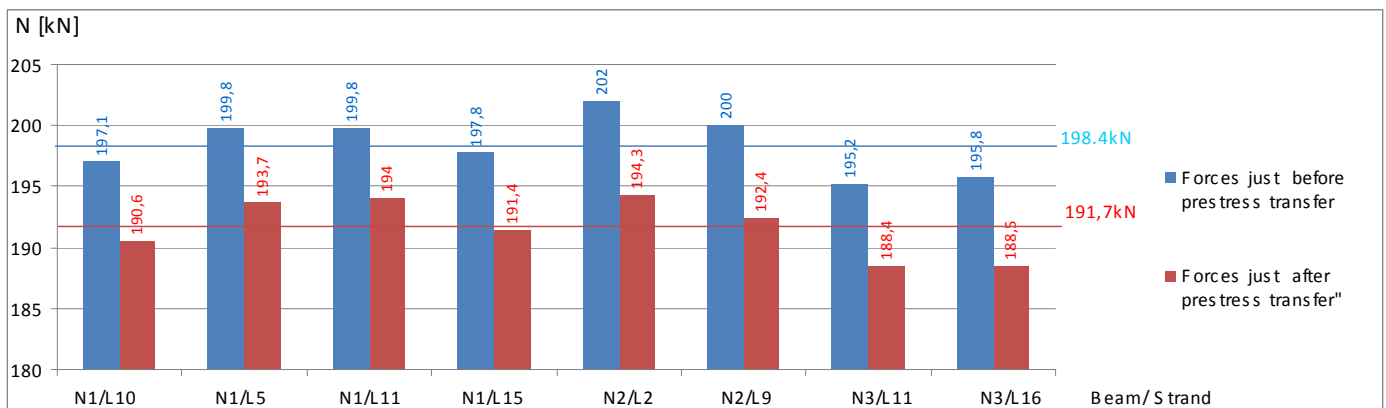
The comparison of prestressing forces in monitored pre-tensioned tendons located in bottom part of the beam is in figure 7. Average value of prestressing force before transfer was 198,4 kN, while minimum projected value 192 kN (used in design), average value just after transfer 191,7 kN. It means that immediate losses due to elastic shortening of concrete were in average -6,7 kN (-47 MPa). While predicted value was -6,9 kN (assumed modulus of elasticity for concrete 38 GPa and prestressing steel 190 GPa).

Figure 7 Measured prestressing forces in the bottom strands

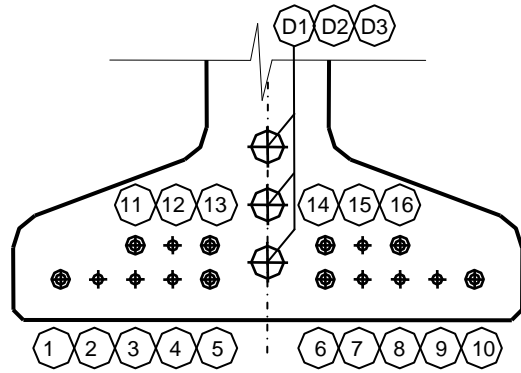
Figure 6 Tendon lay-out and designation

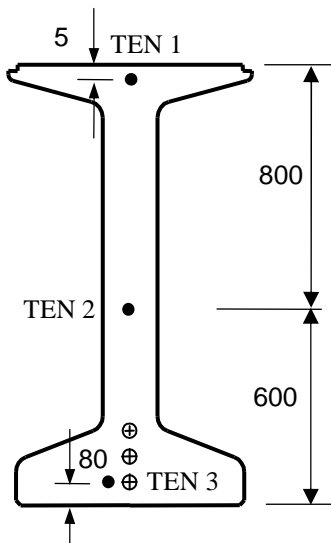
Concrete strains were measured by highly sensitive strain gauges embedded in sections that were located in middle of precast beams. Position of the strain gauges in cross-section is in figure 8. Three strain gauges were used in beam N1, two in beams N2, N3

Figure 8 Position of tensometers

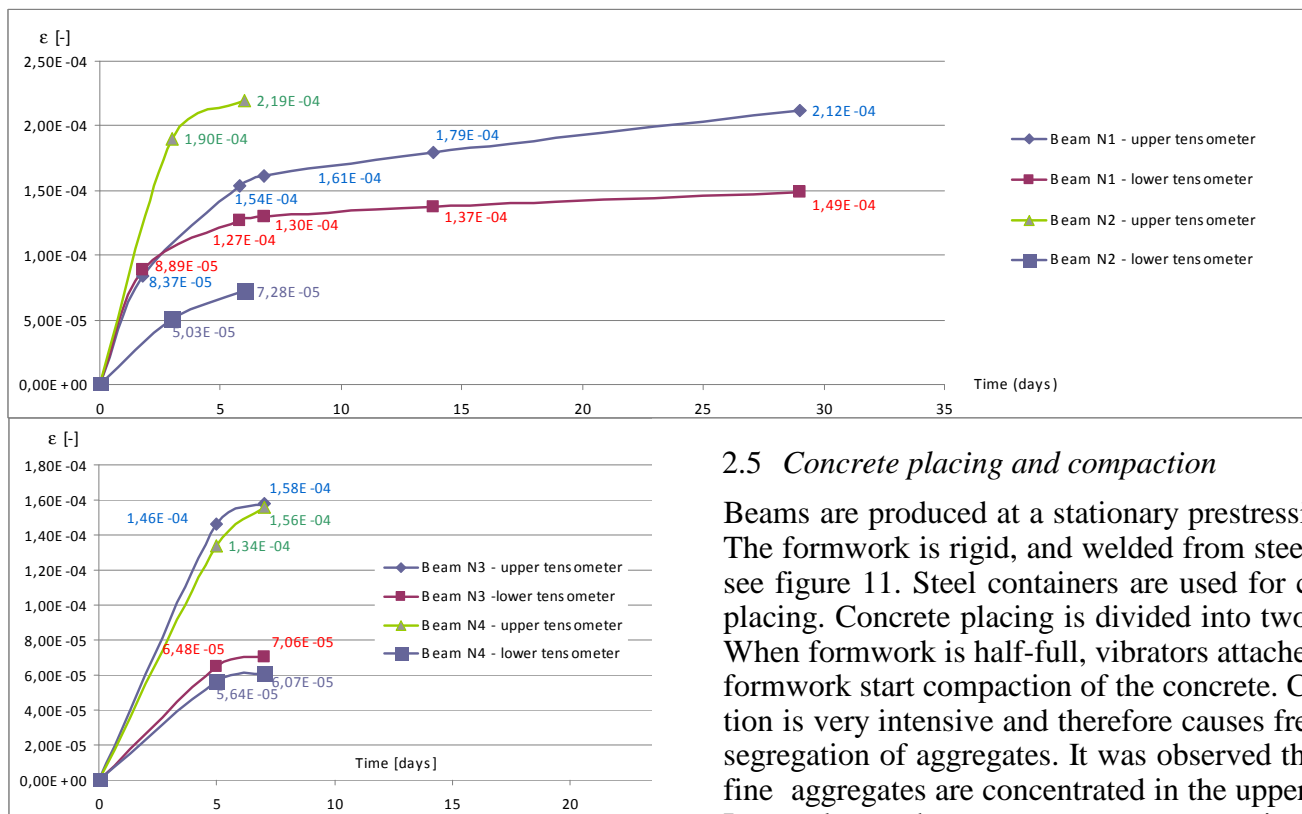
Figure 9 Time development of concrete strains

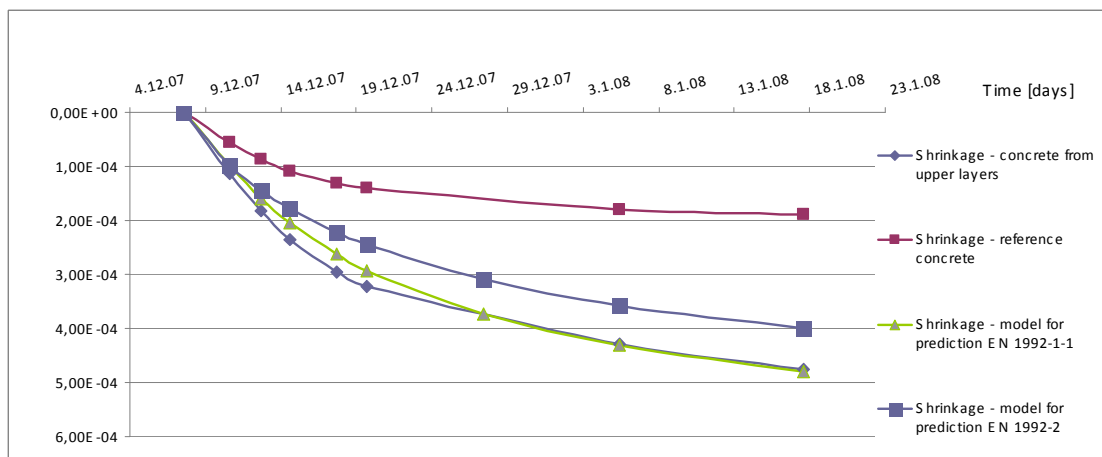
Figure 10 Strains due to shrinkage

Concrete samples were taken from upper layers of the beams just after intensive compaction and tested for shrinkage, modulus of elasticity, compressive strength and density. Results were compared with reference concrete, taken from the same concrete batch. The comparison of the results is in table 3. The results confirmed worse properties of concrete from upper layers compared to the normal concrete. The particular differences between shrinkage of both concrete casts are very significant. Shrinkage of concrete taken from upper flange was two times higher than shrinkage of reference concrete, see figure 10.

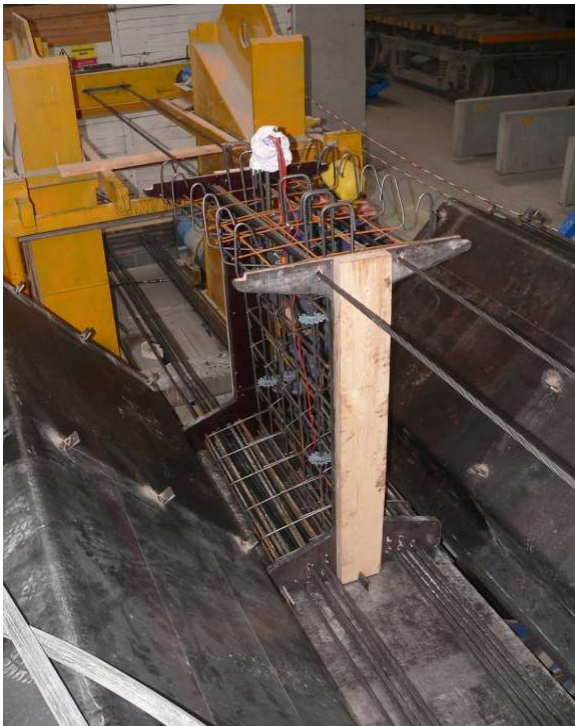
Beams are produced at a stationary prestressing bed. The formwork is rigid, and welded from steel plates, see figure 11. Steel containers are used for concrete placing. Concrete placing is divided into two stages. When formwork is half-full, vibrators attached to the formwork start compaction of the concrete. Compaction is very intensive and therefore causes frequently segregation of aggregates. It was observed that more fine aggregates are concentrated in the upper flange. It makes the concrete cross-section non-homogeneous along the beam depth. This observation was also confirmed by further laboratory tests.

The monitoring and research of this problem is still continuing. In order to separate different effects, we started with monitoring shrinkage on non prestressed segments of the beam (length 1 m). Continuous strands are separated by PE pipes. Segments are made along with a beam in the some formwork, us-

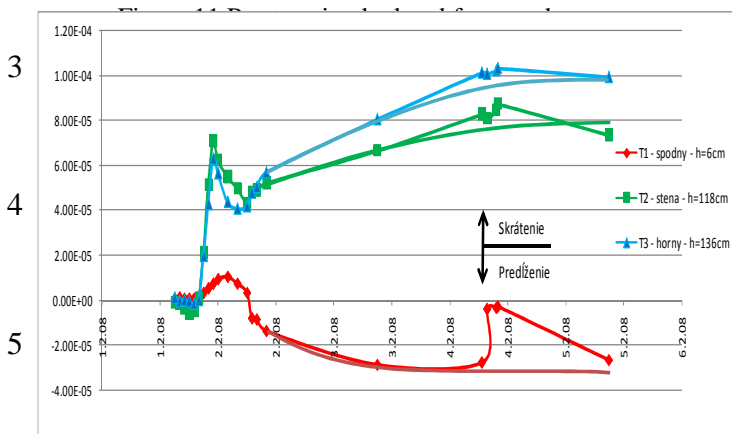
ing the original technology of placing concrete and intensity of vibrators (see figure 11). The results of measurement on the first segment are shown in the figure 12. It is clear that the upper part of segment is very sensitive to extensive shrinkage. Through simple calculation, this effect after 5 days on a 32 m long beam gives about 10 mm of deflection. By measuring shrinkage gradients over the height of segments and comparing them with the reference samples (as shown in chapter 3) we would like to find the answer for technological or technical solution of the camber loss. The first solution was increasing the bending effect of the first prestressing, by partial separation and cutting of upper strands.

Figure 12 Strains due to shrinkage measured on beam segment
